March 12, 2013

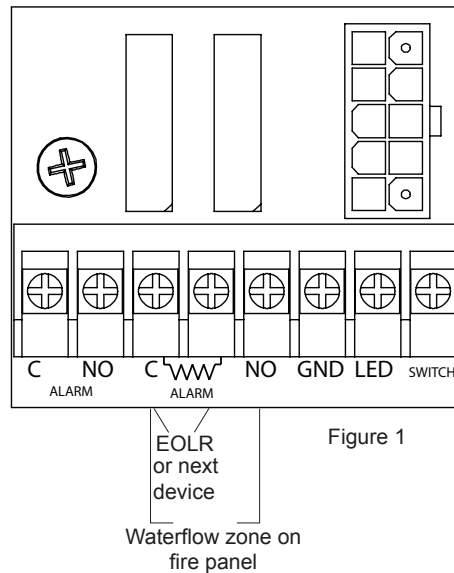
## Fire panel stays in trouble:

Check the wiring. The zone of the fire panel should be wired to the VSR-AT as shown on pg 4 of the [5401239 datasheet](#) and in Figure 1 below. The End of Line Resistor should be installed as shown across the terminals marked C and the terminal to the right of C which is indicated by the other end of the resistor symbol. The zone of the fire panel connects to the terminals marked C and NO.

The NO and End of Line Resistor terminals are connected internally by a normally energized relay. A loss of power or failed AutoTest causes the relay to drop out and initiates a trouble at the fire panel.

The only way to clear the trouble on the fire panel is to conduct a successful AutoTest using the ATC test switch or other test method. Conducting an actual waterflow test will put the panel in alarm but will not clear the trouble.

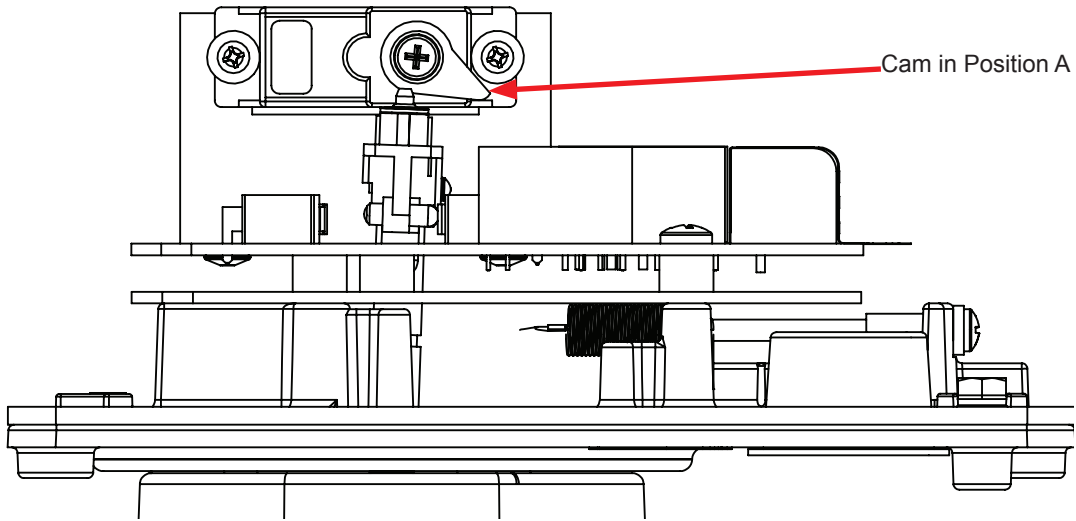
Figure 2

## Is the cam on the AutoTest motor stuck on the trip stem?

If the cam does not travel properly and the cam appears to be jammed by the trip stem, the trip stem set screw should be adjusted. This may occasionally happen if the electronic retard was removed from the base and replaced. See figures 1, 2 and 3 of this document.

1. To adjust the cam set screw it may be necessary to remove the clear cover guard. The clear cover guard can be removed by unscrewing the mounting screw that holds it in place.
2. Using a 1.3 mm hex screwdriver, loosen the trip stem set screw a  $\frac{1}{4}$  turn in the counter clockwise direction. (See Fig. 4)
3. Retest the VSR-AT Auto Test Function.
4. If this resolves the jamming issue and the test results are favorable then the unit is ready for use. Replace the clear cover guard and verify that the unit again tests normally.
5. If not then try repeating steps 2 through 4.
6. If the issue is not resolved after six  $\frac{1}{4}$  turn adjustments (1  $\frac{1}{2}$  full turns) then replace the electronic assembly with a new one. The electronic assembly might be defective.

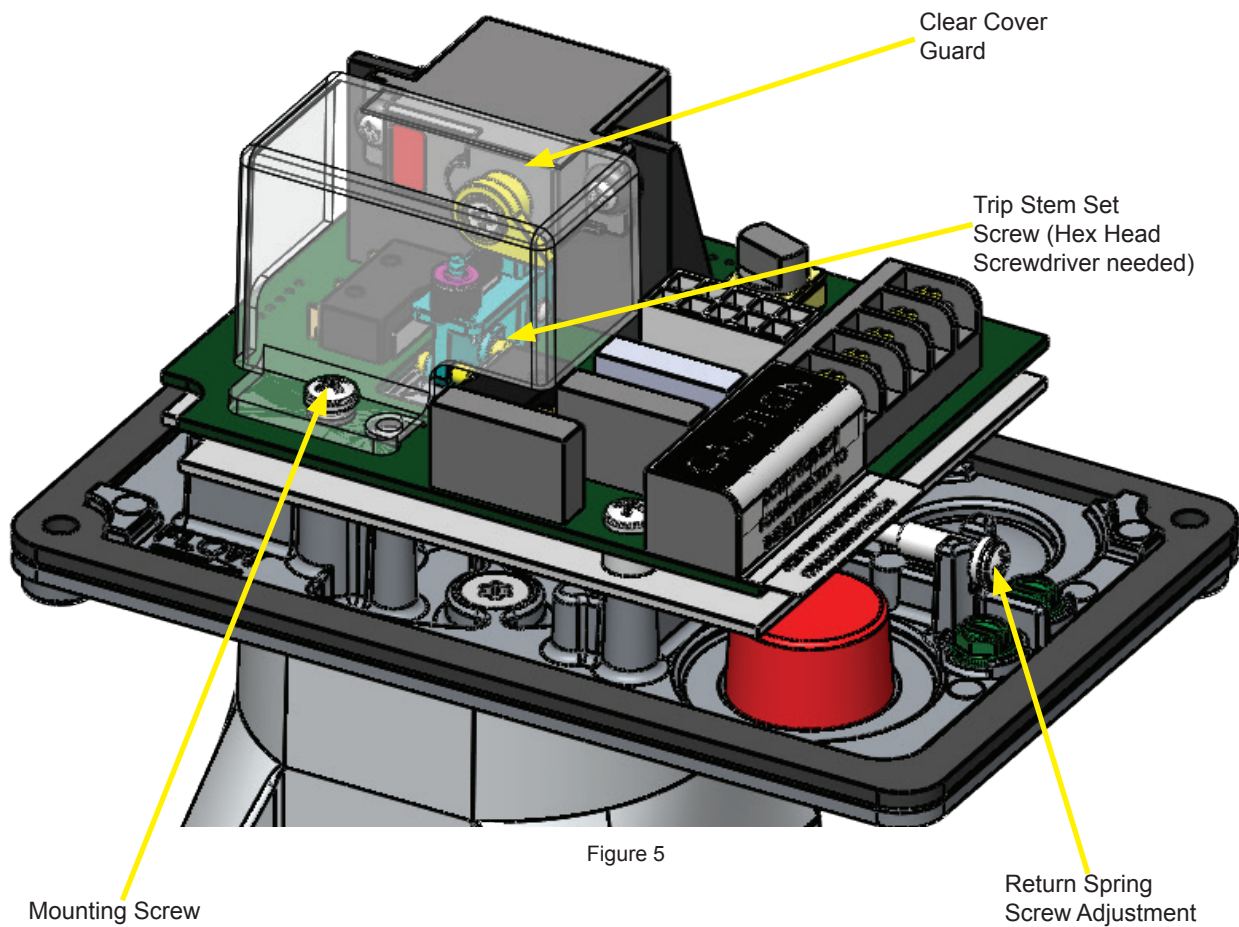
Figure 5

### Has the return spring on the VSR-AT been adjusted?

This spring has been factory set and should not be adjusted in the field. Refer to Figures 5 & 6 of this document to determine the factory spring setting. If the spring is not at the factory setting, turn the spring adjustment screw until the factory spring setting is restored.

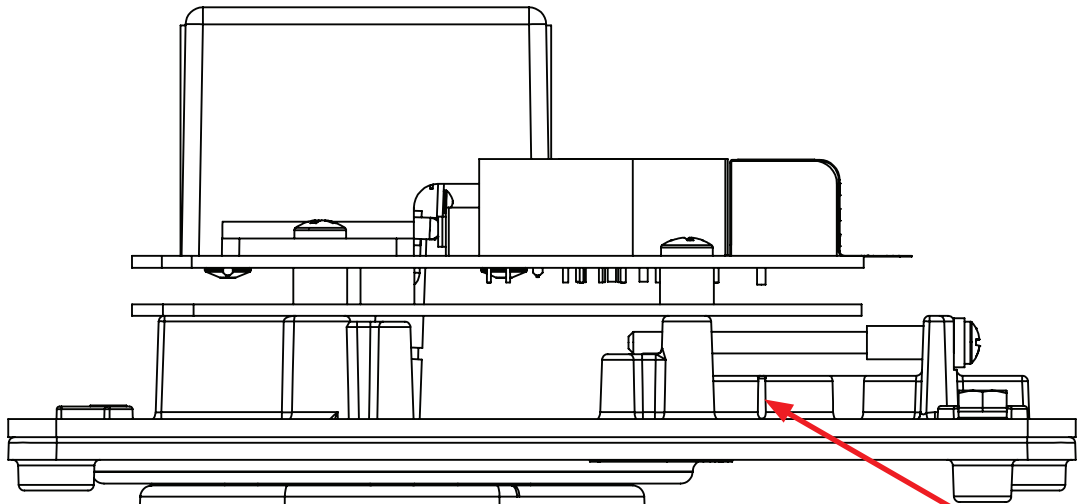
Figure 6

Factory Mark

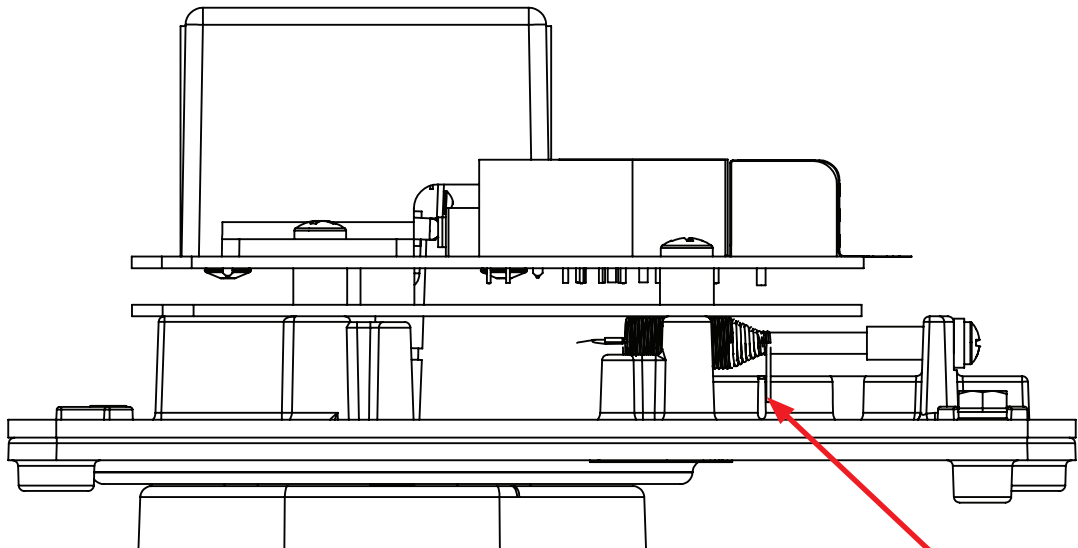
Figure 7

Return Spring set to  
Factory Mark
